# EVALUATION OF LOCAL CONTAMINATION SOURCES FROM THE FORMER MINING OPERATION IN MAARMORILIK

NERI Technical Report no. 807    2010

Title: Evaluation of local contamination sources from the former mining operation in Maarmorilik

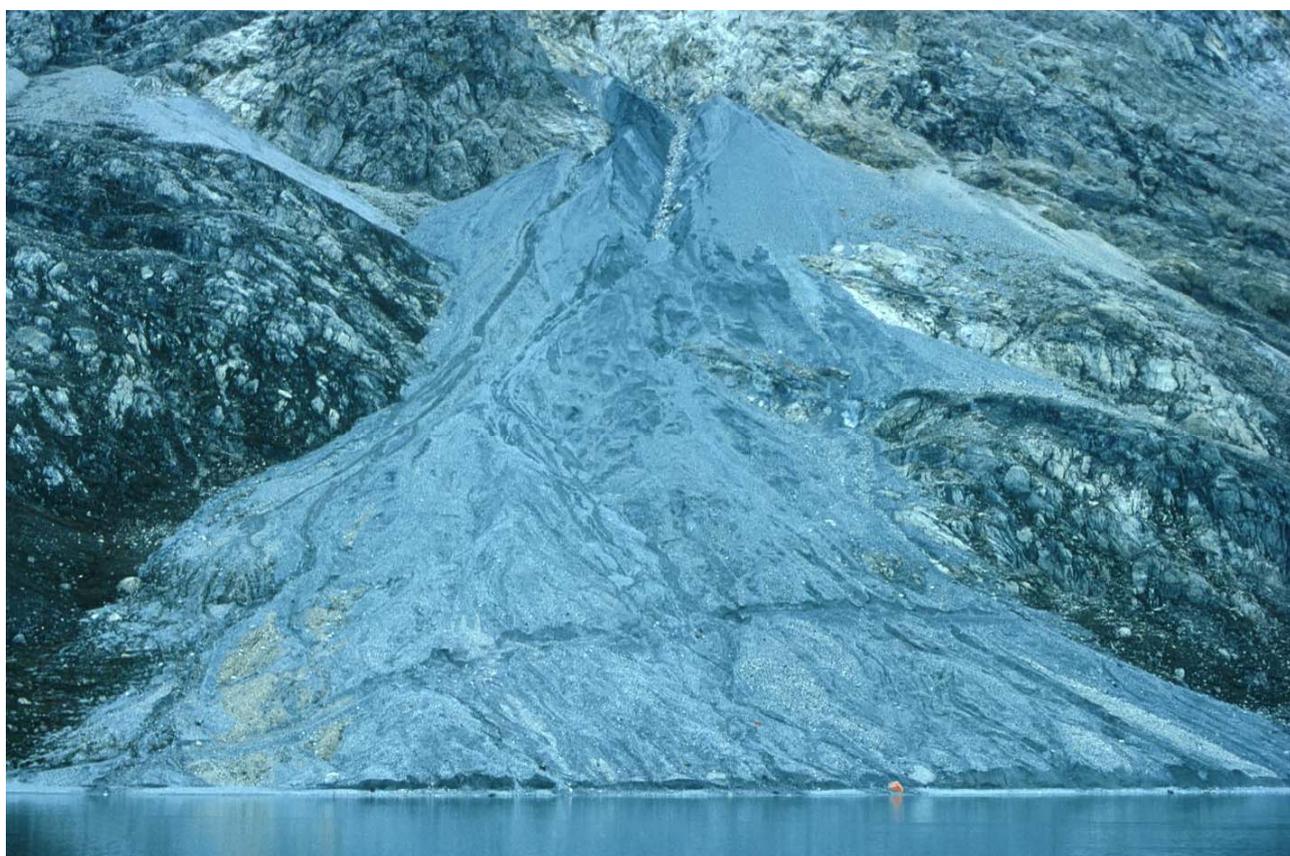
The North Face dump in 1986 (Photo: Poul Johansen).

In June 1990 two excavators and four bulldozers started to bring the dump material to sea level from up to 260 metres a.s.l. The dump had a slope of about 30°. It was partly frozen and had to be blasted. Two dumpers and two frontend loaders were used to load the dump material into a split barge, which emptied about 800 tons at one time into the dumping area in Affarlikassaa. Some turbidity could be seen for about 10 minutes after the barge had emptied a load. It was estimated that 320000 tons of waste rock was dumped into Affarlikassaa. But then the dumping became a political issue, and the dumping had to be stopped on August 22. The MRA had to change plans and it was decided to place the remaining part of the waste dump in the waste storage in the area of the old concentrate building. This meant that the waste rock had to be unloaded at a quay that was constructed in Maarmorilik and transported on dumpers and it was not possible to avoid spillage of waste rock in Maarmorilik during that process, because the equipment used was not suited for the work (this was an un-planned operation). During unloading and transport, spill of waste was observed, maybe 1-2% of the amount transported. After the work was finished, the top layer of the quay area and the road between this and the former concentrate building was dug up and transported to the waste deposit in the former concentrate building. One quarter of the dump was deposited in this waste storage area on top of previous stored remains of buildings and equipment as described in other parts of this report. Afterwards the waste storage was covered with a layer of clean crushed marble. It was not possible to move the whole dump and a significant, but unknown amount is still present underwater below the dump foot. Without doubt, some remains of waste rock have also been left in Affarlikassaa at the quay area, which was constructed for unloading waste rock. Finally, some remains are also left on land at the quay and on the road used to transport the waste to the former concentrate building.

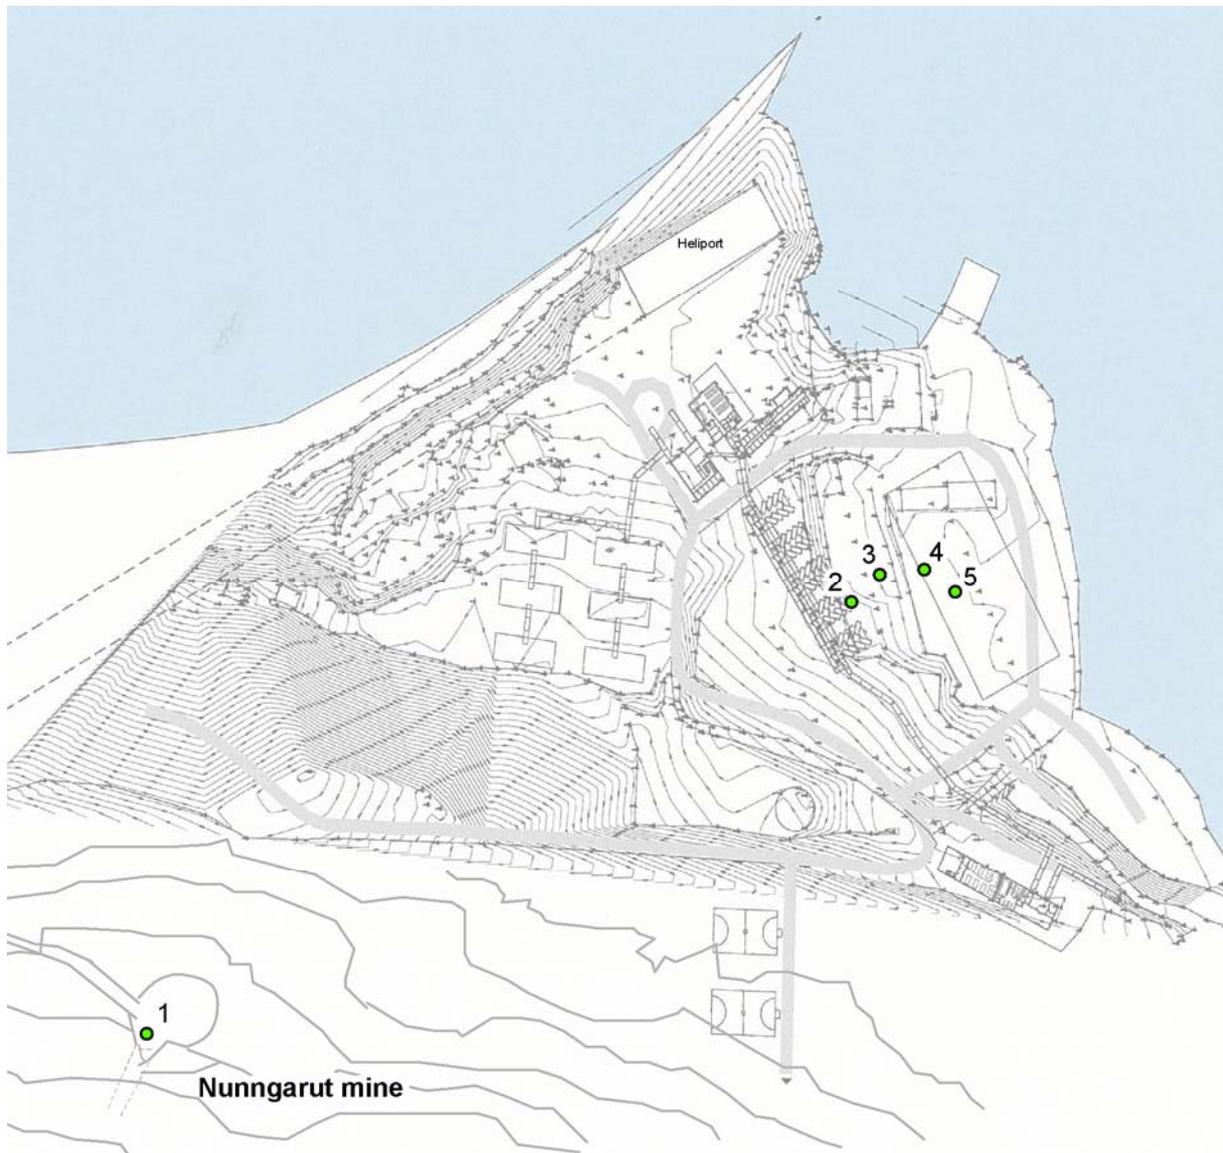
Figure 2. Map of Maarmorilik indicating the sites where soil samples (1-5) was taken in 2008 (see picture below).

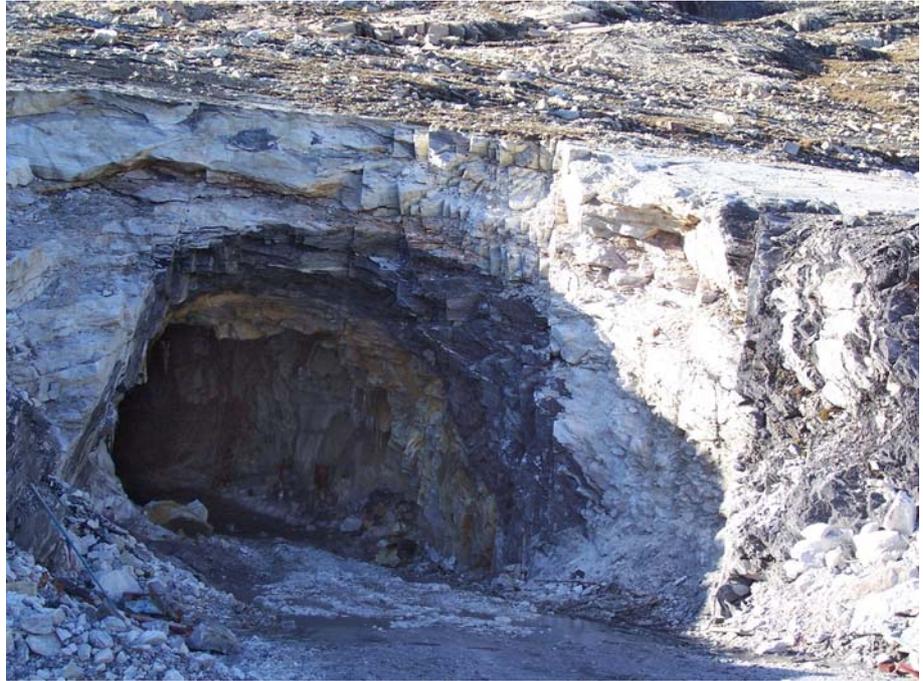
**Sample 1.** Entrance to the Nunngarut tunnel. Photo: Doris Schiedek.

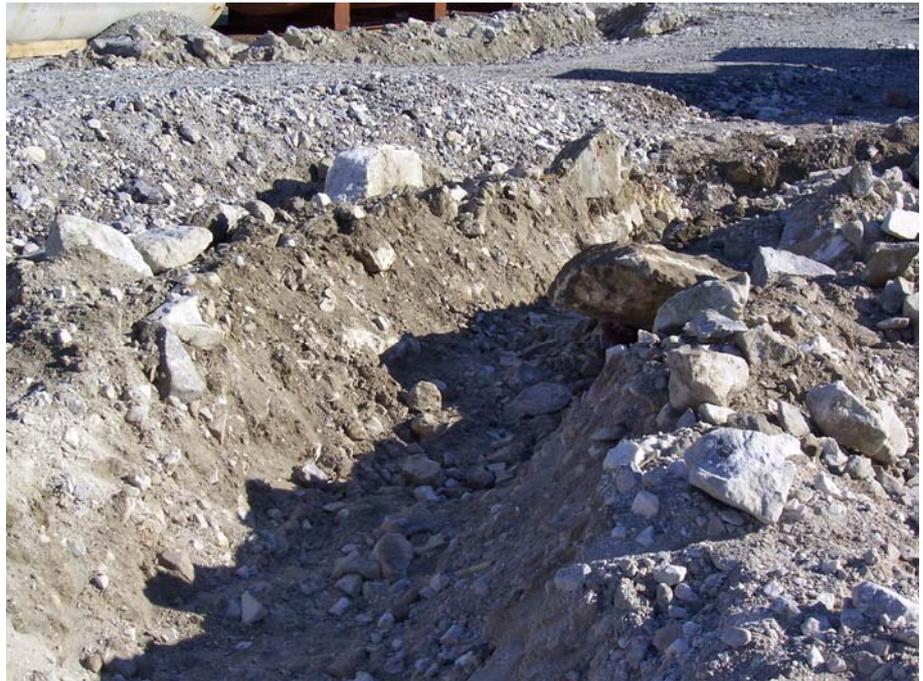
**Sample 2 and 3.** Composite soil sample from a trench (about 50 cm deep) made below the old concentrate storage building. Photo: Doris Schiedek.

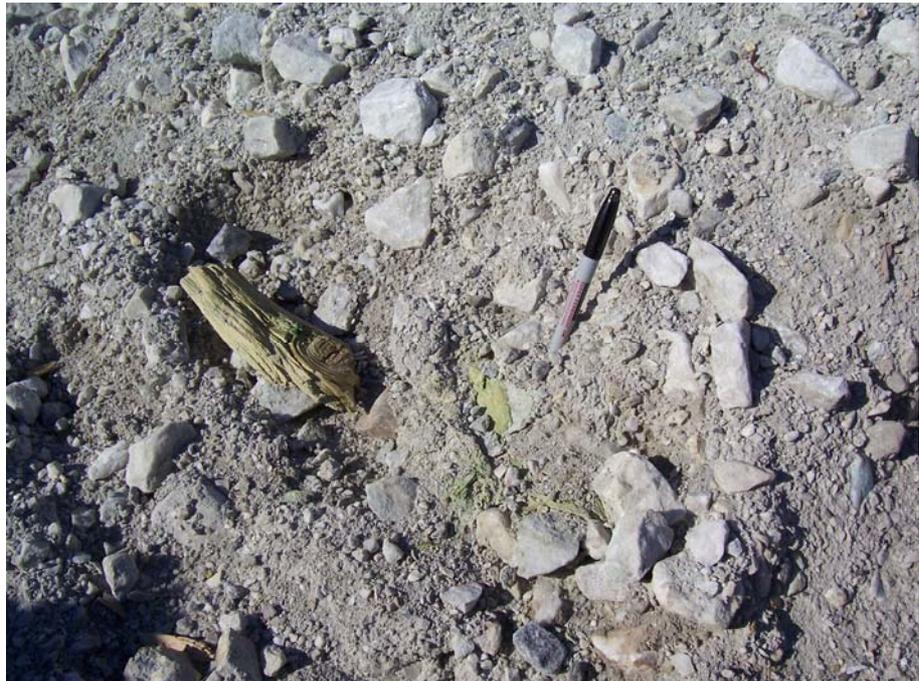
**Sample 4.** Composite soil sample from the same trench with unknown green precipitate on the surface. Photo: Doris Schiedek.

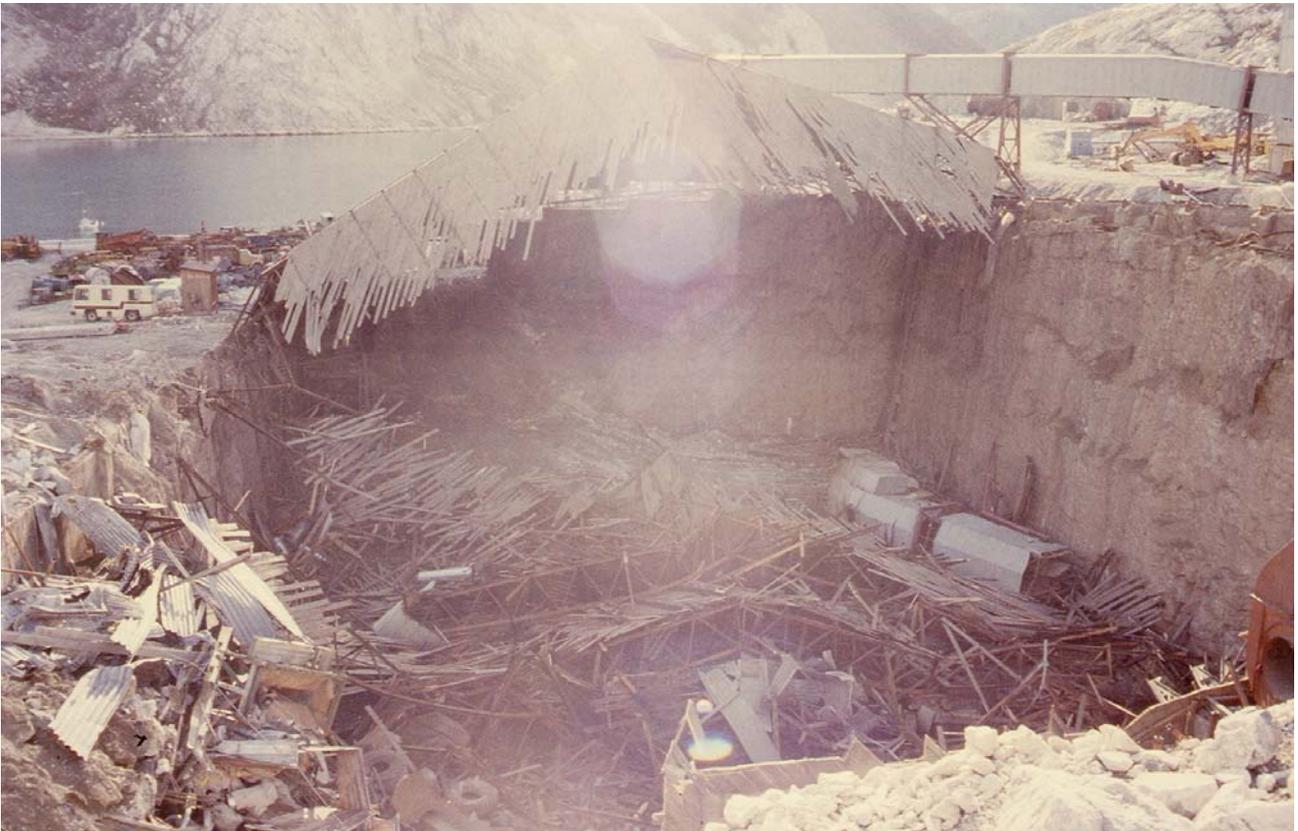
Concentrate storage building during demolition partly filled with waste. August 29.

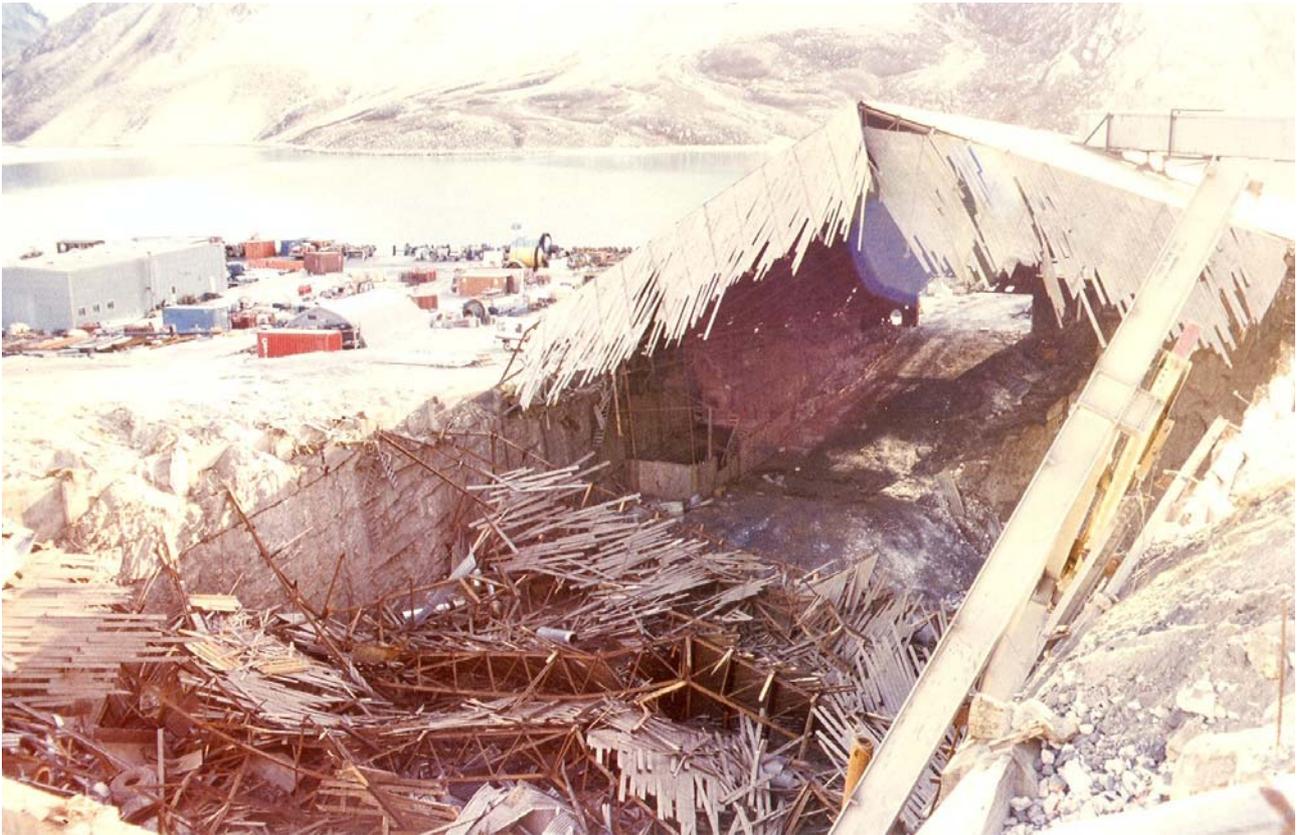
Concentrate storage building during demolition. August 29.

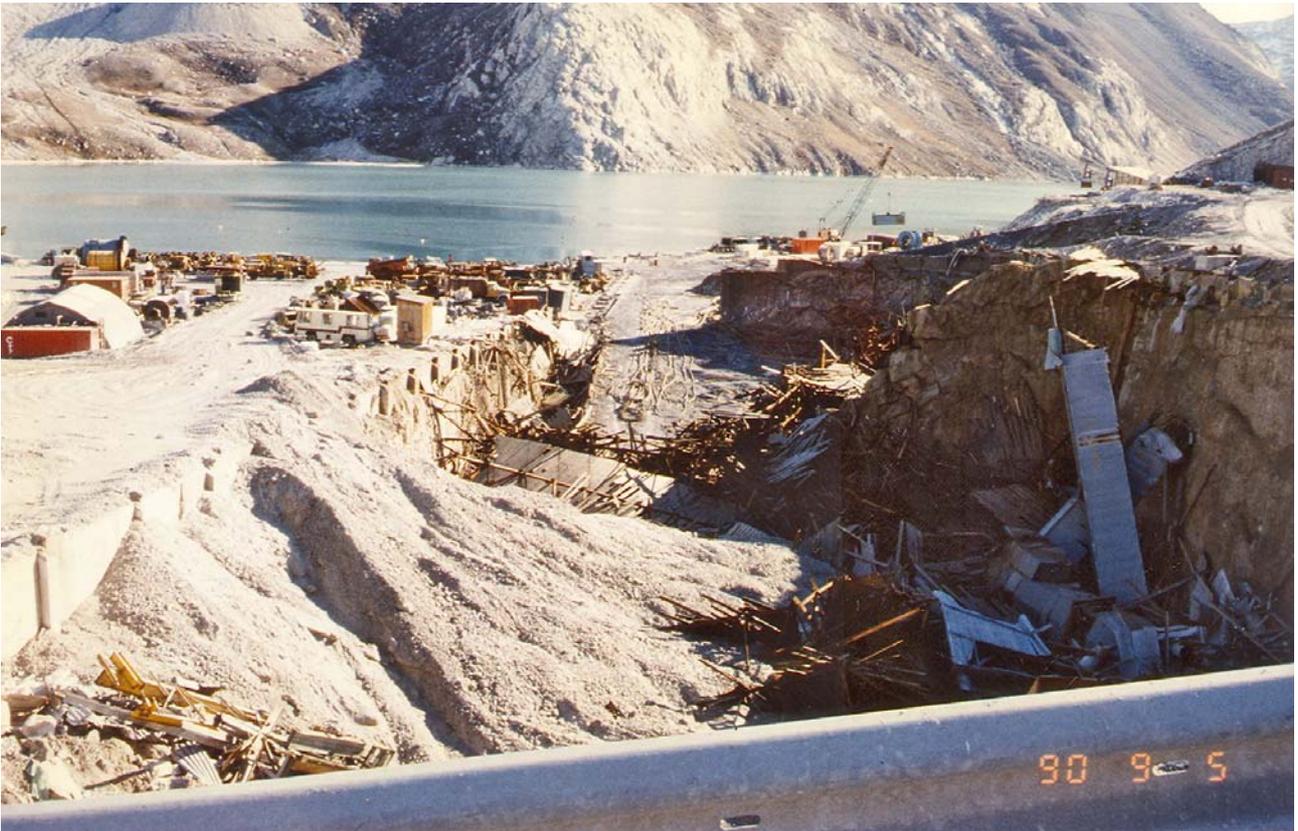
The concentrate storage building demolished containing a lot of waste and a small amount of "Old waste rock Dump". September 5.

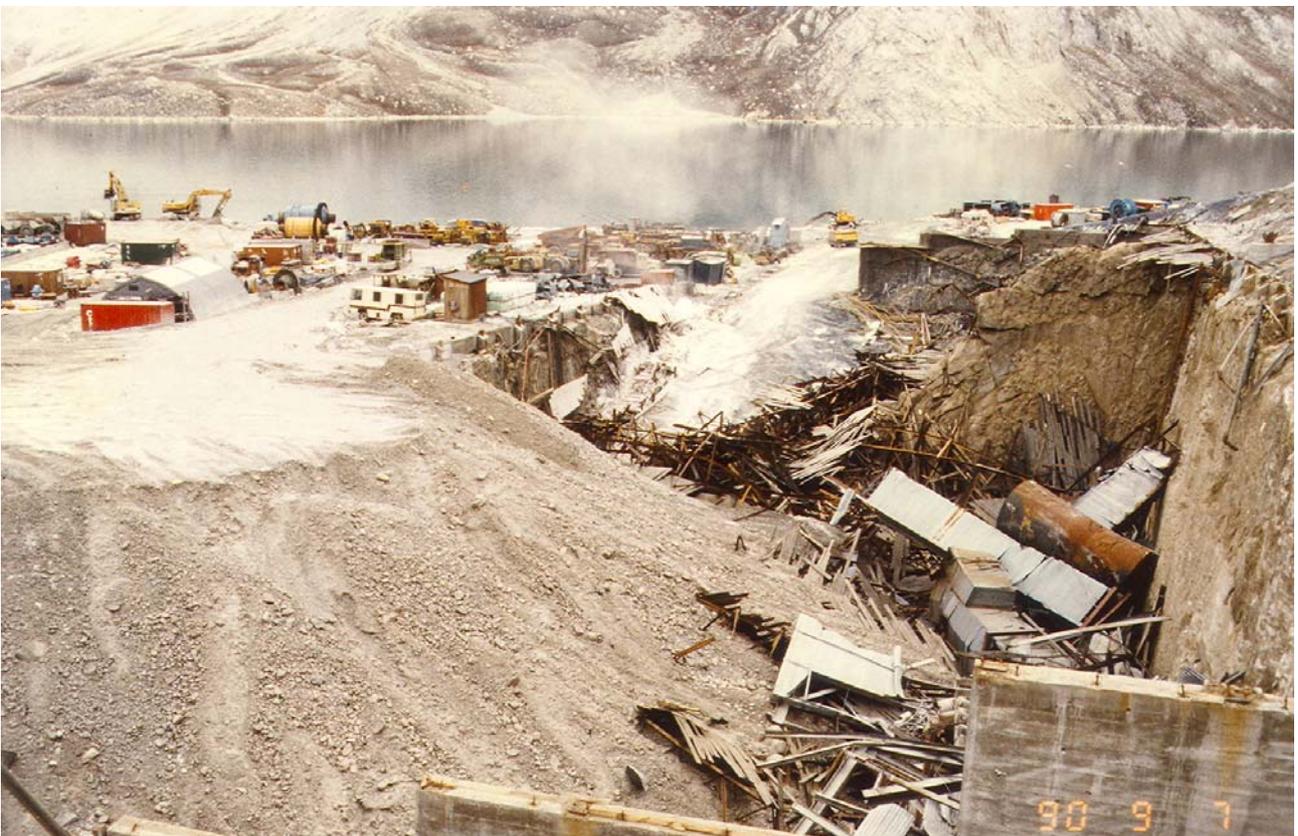
The concentrate storage building with more waste rock dump. September 7.

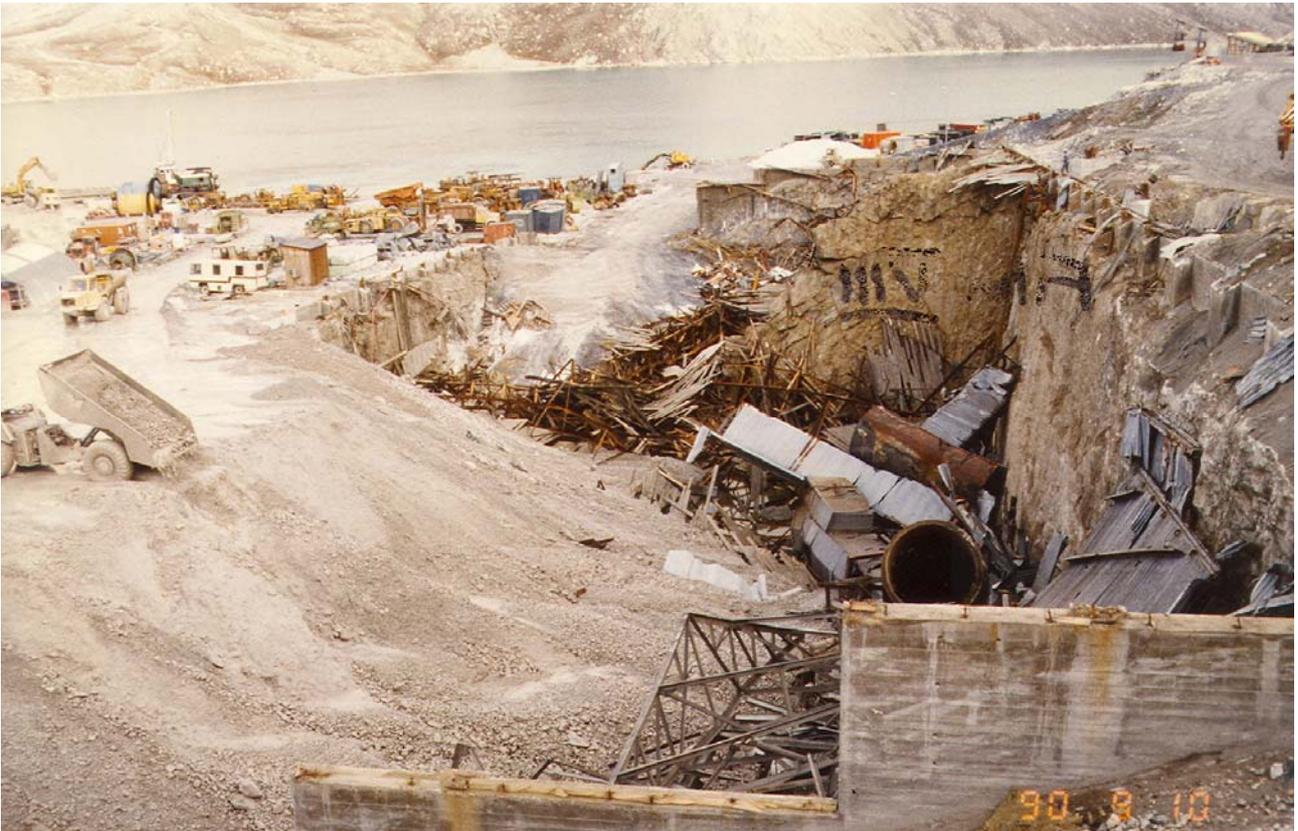
The former concentrate storage building filled with waste and waste rock. September 10.
